FINAL REPORT

April 22 - July 21, 1986

SSME MAIN INJECTOR 4000 HERTZ PHENOMENON

Vibration and Acoustics, Inc.
3011 South Morgan Circle
Huntsville, Al. 35805

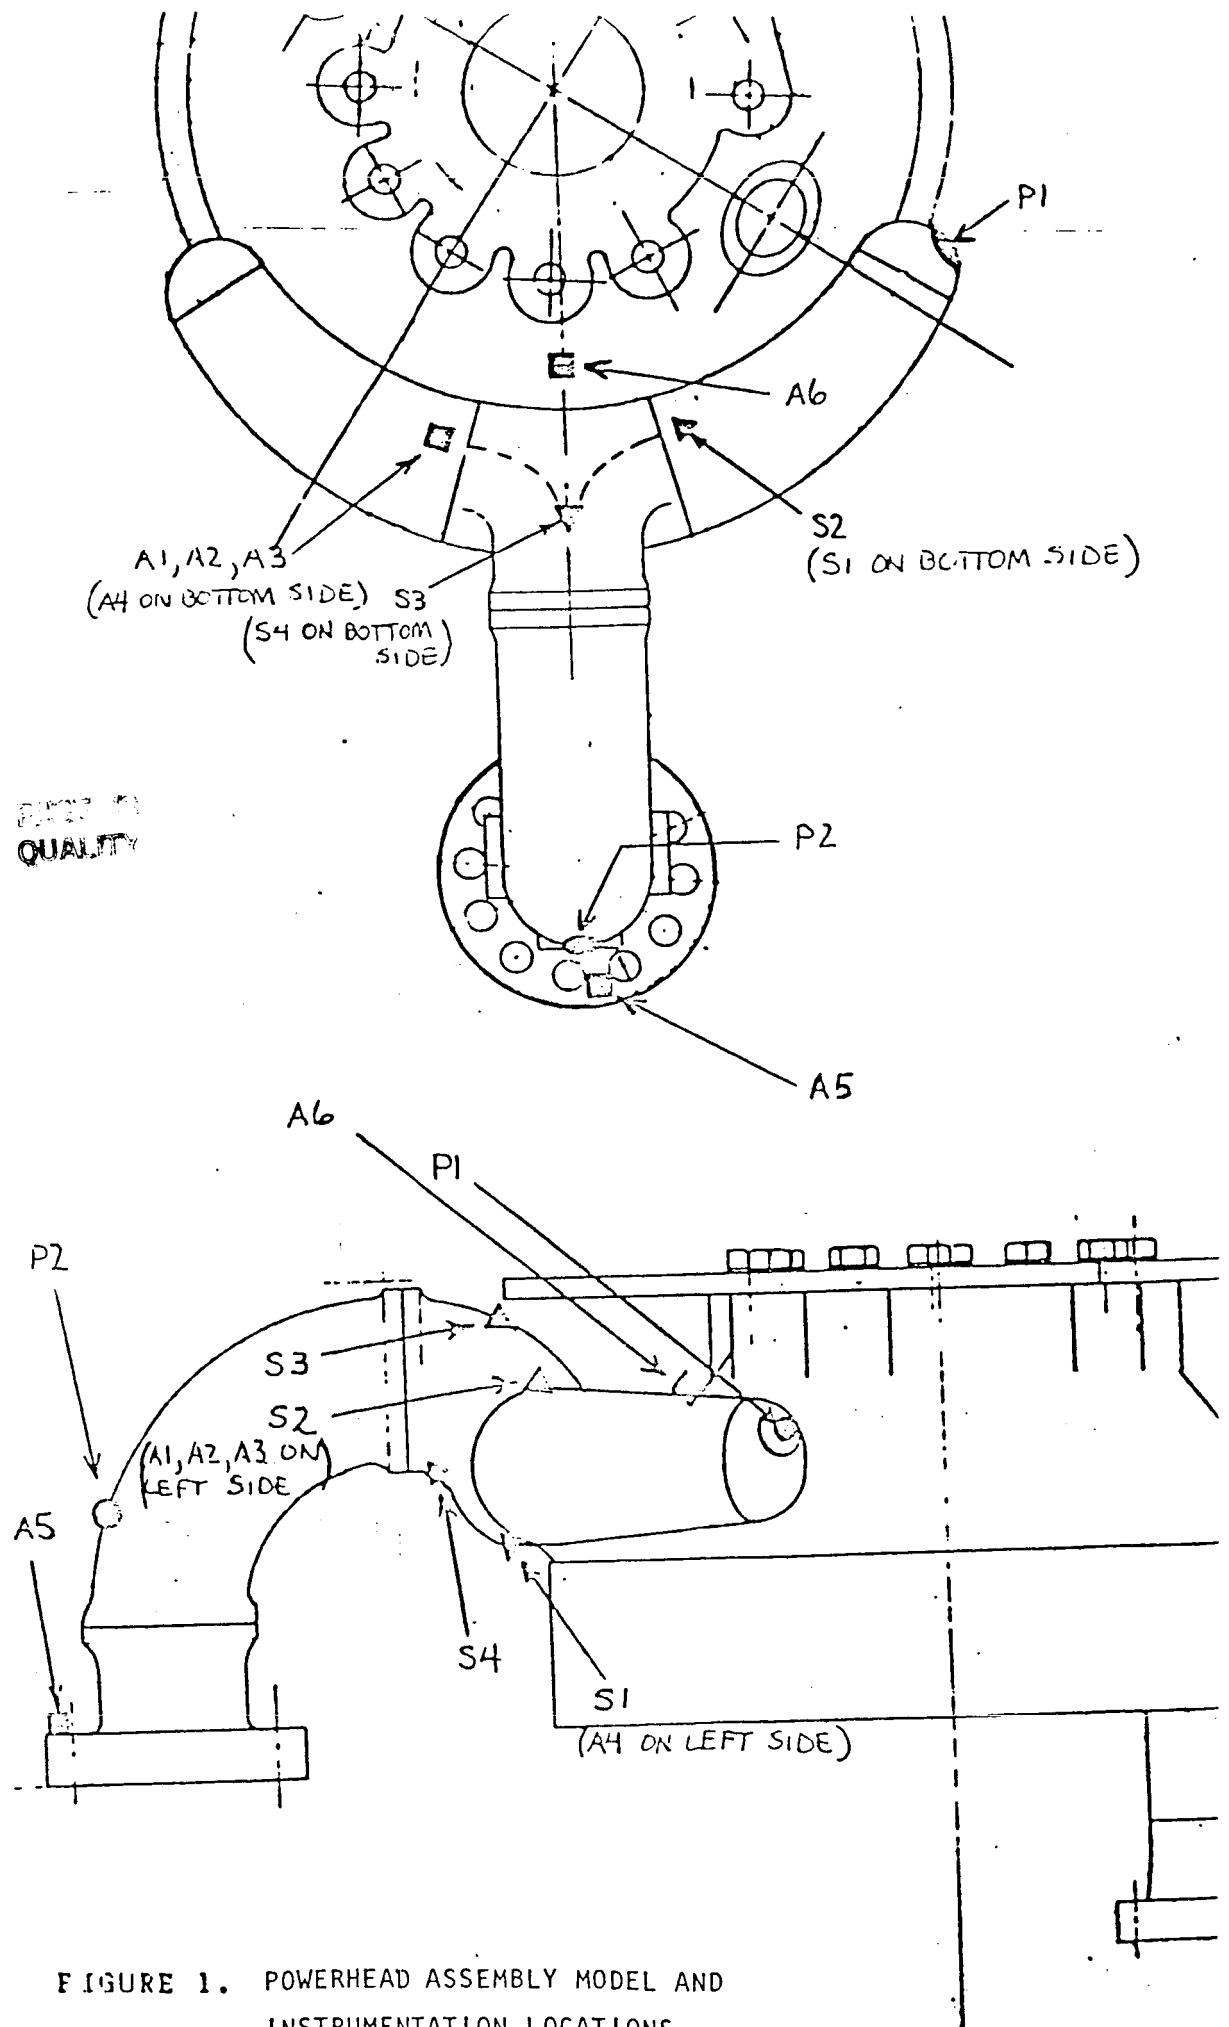
FIGURE 1. POWERHEAD ASSEMBLY MODEL AND
INSTRUMENTATION LOCATIONS

Figures 1 and 2 show the location and number of accelerometer, pressure and strain gages used to record data during the various flow tests. These sketches show the basic structure used in the test setup; however, the overall setup was more involved.

Instrumentation problems developed during the early low-level flow tests. The author assisted in acquiring replacement pressure transducers for damaged ones following the flow tests on April 15. The accelerometers located on the 'hot dog' near the splitter vanes (particularly A4) were being shaken off. One accelerometer was literally shook apart. The author was requested to provide an expert in epoxy bonding to reattach the accelerometers. Vibration and Acoustics, Inc., paid Mr. Bill White to install the accels on four occasions. The author ordered a large supply of the epoxy that Rocketdyne uses (Kalex D-85) and also obtained
